DEPARTMENT OF TRANSPORTATION**DIVISION OF ENGINEERING SERVICES**

Contract #: 04-0120F4Cty: SF/ALA Rte: 80 PM: 13.2/13.9File #: 69.28**WELDING INSPECTION REPORT****Resident Engineer:** Pursell, Gary**Address:** 333 Burma Road**City:** Oakland, CA 94607**Report No:** WIR-013845**Date Inspected:** 06-May-2010**Project Name:** SAS Superstructure**OSM Arrival Time:** 1900**Prime Contractor:** American Bridge/Fluor Enterprises, a JV**OSM Departure Time:** 700**Contractor:** Zhenhua Port Machinery Company, Ltd (ZPMC), Changxing Island **Location:** Shanghai, China**CWI Name:** See Below**CWI Present:** Yes No**Inspected CWI report:** Yes No N/A**Rod Oven in Use:** Yes No N/A**Electrode to specification:** Yes No N/A**Weld Procedures Followed:** Yes No N/A**Qualified Welders:** Yes No N/A**Verified Joint Fit-up:** Yes No N/A**Approved Drawings:** Yes No N/A**Approved WPS:** Yes No N/A**Delayed / Cancelled:** Yes No N/A**Bridge No:** 34-0006**Component:** OBG**Summary of Items Observed:**

OBG Bay 14

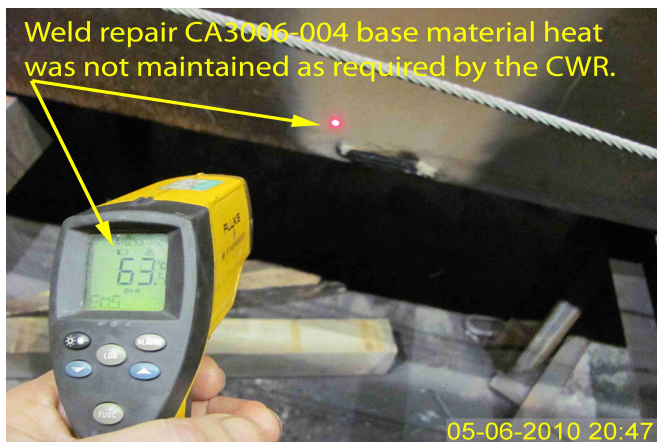
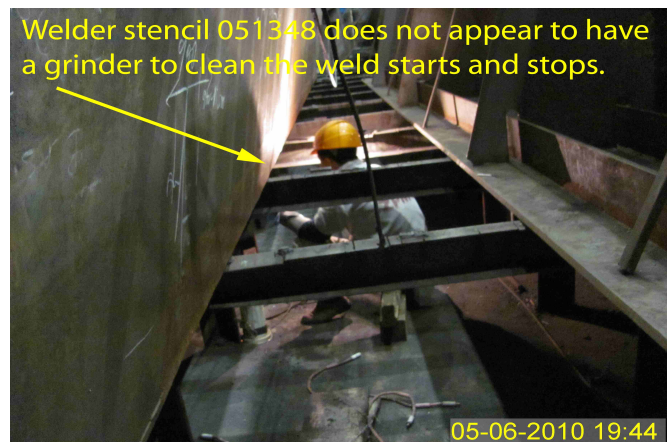
This QA Inspector observed ZPMC welder Mr. Li Jun, stencil 051348 is using shielded metal arc welding procedure specification WPS-345-SMAW-2G(2F)-Repair-1 to complete OBG corner assembly critical weld repair CA3006-004 in the 2G position. This QA Inspector measured a welding current of approximately 170 amps and that Mr. Li Jun appears to be certified to perform this welding. This QA Inspector performed a document review of critical weld repair document B-CWR-1451 and observed step 3D states the CWI shall verify the welder understand that the weld starts and stops that will impact fusion will be ground. This QA Inspector observed Mr. Li Jun used a chipping hammer to remove welding slag and Mr. Li Jun did not appear to be using a grinder to clean the weld starts and stops. This QA Inspector informed CWI Mr. Zhu Zhong Hai of the critical weld repair requirements and Mr. Zhu Zhong Hai said he had recently observed Mr. Li Jun to be adequately cleaning the welding starts and stops. This critical weld repair document also requires the base material to be preheated with electrical heating elements to a minimum of 160 degrees Celsius and that this heat is to be maintained through the welding cycle and maintained for a period of time as part of the post weld heat treatment. This QA Inspector

observed the adjacent base material was at an elevated temperature, but it appears to be less than the required 160 degree Celsius. This QA Inspector informed CWI Mr. Zhu Zhong Hai that the base material temperature is below the minimum of 160 degree Celsius and Mr. Zhu Zhong said ZPMC will re install the electric heater to keep the base material warm. Approximately 30 minutes after completion of the welding this QA Inspector observed the base material on one side of the repair is approximately 160 degree Celsius and the other side is approximately 63 degrees Celsius. This QA Inspector informed ZPMC QC Inspector the base material adjacent to the weld repair does not appear to be maintained to a minimum of 160 degrees on one side of the weld repair. The temperature measurements were obtained using a ZPMC owned infrared type temperature measurement device. Items observed on this date do not appear to fully comply with applicable contract documents. See the photographs below for additional information.
